## Manhole/Vault Oil and Sheen Removal

Mid-Atlantic Region - May 2007

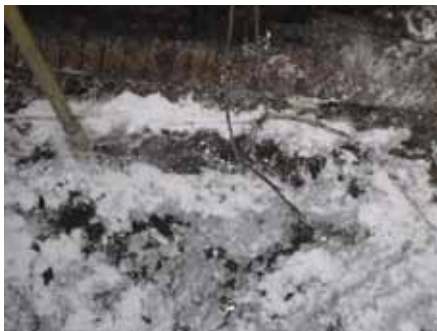
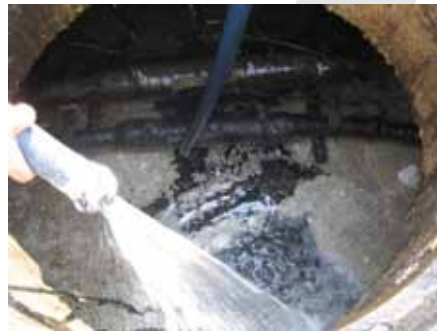
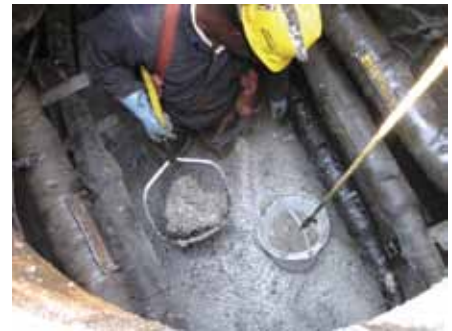
C.I.Agent® Granules were broadcast into the manhole onto the surface of the oily water. A pump was lowered into the vault and the water was pumped back into the vault, mixing the C.I.Agent® Granules with the oil to create a washing action to address the extreme contamination on the splices, cable racks, and wall areas. After allowing the solidified oil to settle on the surface, the water level was pumped down. The remaining solidified oil was removed from the vault; placed into bags for disposal and the remaining water was pumped out.
